Post-test Examination of a Pool Boiler Receiver

Robert L. Dreshfield, Thomas J. Moore,
and Paul A. Bartolotta
National Aeronautics and Space Administration
Lewis Research Center

April 1992

POST-TEST EXAMINATION OF A SUBSCALE POOL BOILER TEST APPARATUS

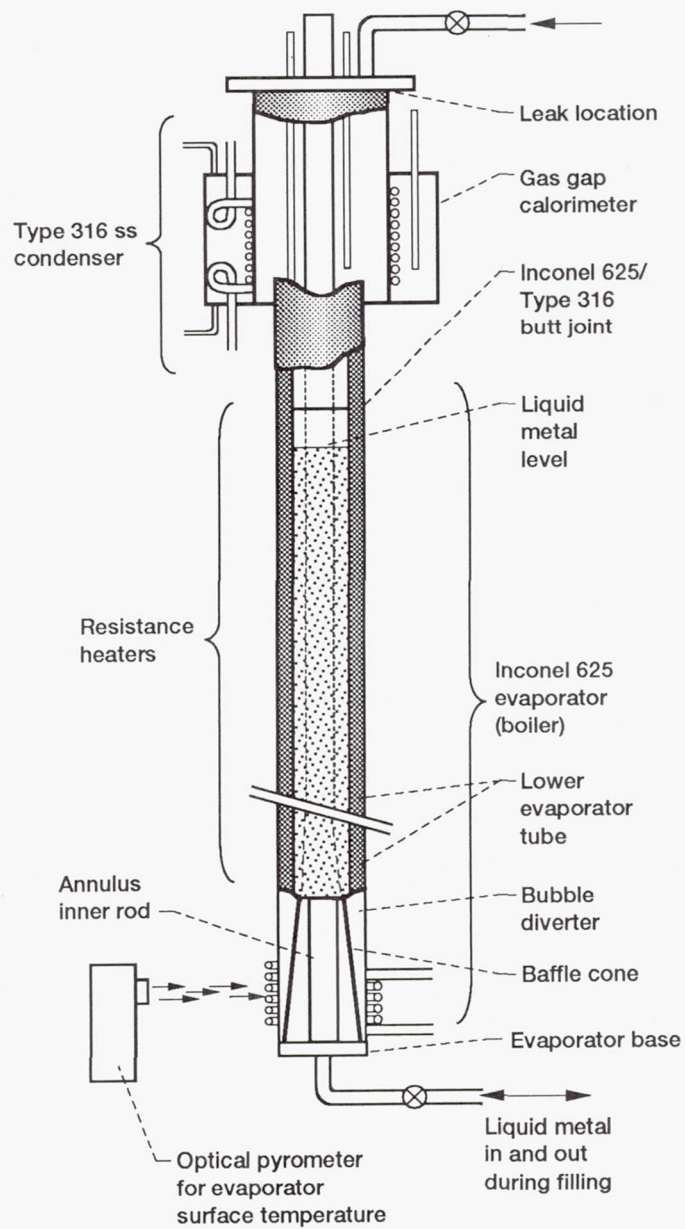
Figure 1.—Subscale pool boiler test assembly.

Sandia National Laboratories is evaluating Stirling engines for terrestrial solar applications under the Department of Energy's Solar Thermal Technology Program. The NASA Lewis Research Center is providing management of the Advanced Stirling Conversion System project for the DOE (ref. 1). As part of the project a subscale pool boiler test apparatus was used to evaluate boiling stability of a reflux boiler receiver. The test apparatus was designed and tested by Thermocore, Inc. for Stirling Technology Company under NASA Contract DEN3-377 to provide experimental data on boiling stability for the design of a refluxing pool boiler receiver. The subscale boiler was operated with eutectic NaK for 791.4 hr at temperatures from 700 to 750 °C including 82 cold starts and 60 warm starts (ref. 2). The operation was discontinued when gas was observed in the condenser of the device. After the test apparatus was shut down and the insulation removed, two small leaks were detected by Thermocore personnel in the vicinity of the weld between the condenser and flange at the top of the condenser. The general configuration of the test apparatus and the location of the leaks are shown in figure 1.

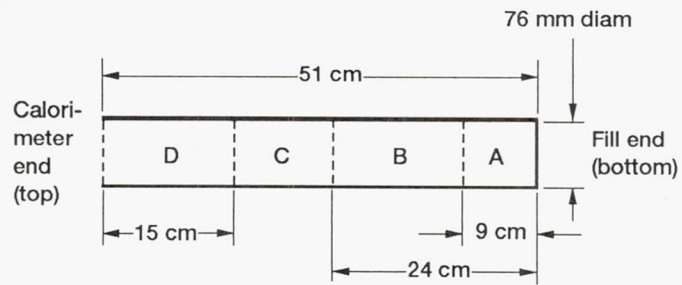
Figure 10.—Sub-scale boiler cut-up plan.

The boiler section was cut into 4 sections as shown in figure 10. Sections B and D were about 15 cm long and tensile test samples were prepared from these sections. The tensile test specimens were wire electric discharge machined such that the test section was "dog bone" shaped. The gage length was 25 mm long and 8 mm wide. The grip was about 38 mm long and was flattened for testing. The overall specimen length was about 14 cm. In addition metallographic examination was performed on material taken from sections A, B and D.
